Summarized Case Study (RW)

Key Words: RW reservoir, blue-green algae, taste and odor, hypolimnetic oxygenation, manganese, hydrogen sulfide, dissolved oxygen, impaired fishery

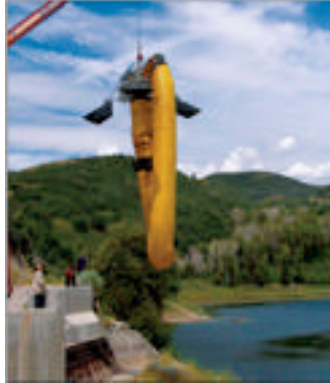
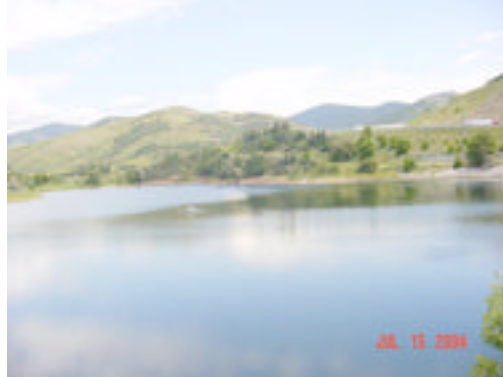
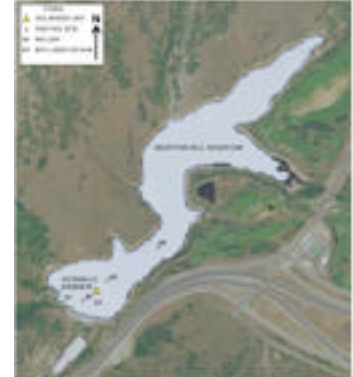
Photos: First photo shows the SolarBee being installed in the reservoir; second photo shows unit in the lake; third photo is an aerial shot showing the location of the SolarBee by the dam in the lower reservoir.

SolarBee Installation: Date: July 2004, installed one (1) SB10000v12 near the dam in the lower reservoir. The unit's down hose was set at 45 ft below the water surface, keeping it 10 ft below the intake.
